Manhole Inspection Summary

Manhole # S29EE_032MH

Location Address: **1214 EUTAW PL**

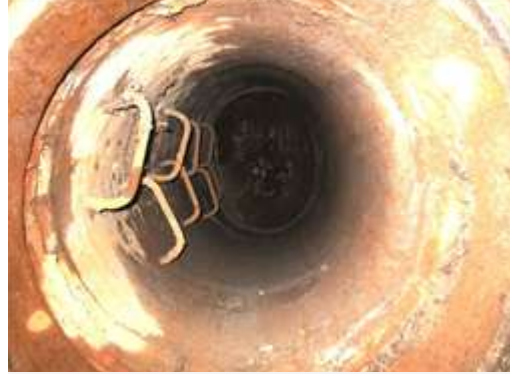
Top View

Corroded steps. Channel debris.

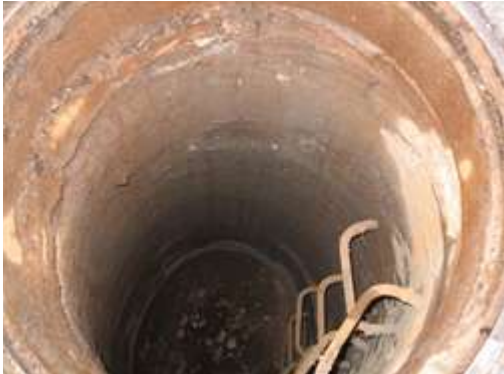
Defect

Frame leaks. Adjustment deterioration and infiltration. Barrel infiltration - other side.

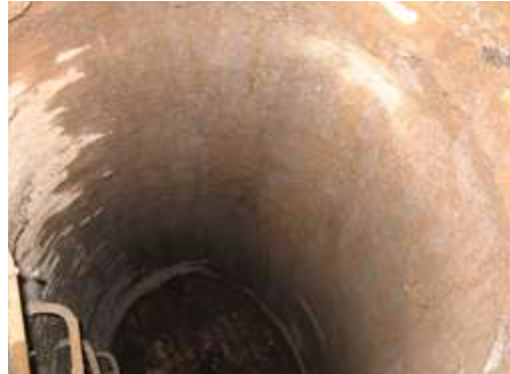
Defect

Frame leaks. Adjustment deterioration and infiltration. Barrel infiltration.

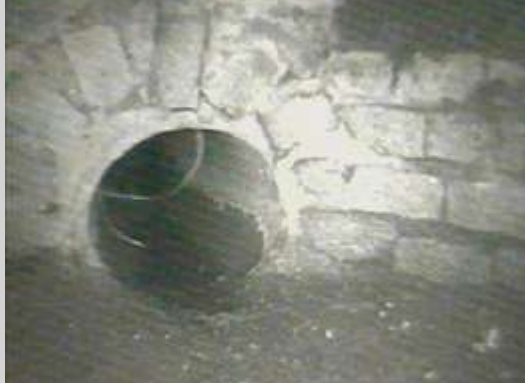
8 in. Circular Gravity Sewer
Pipe Out @ 12 O'Clock

Deposits: ☐ None ☒ **Mud** ☐ Sludge ☒ **Debris** ☐ Grease

Infiltration: **Evidence** Pipe Seal Cond: **Cracked**
